**Tornado incident at the  
Freeport Container Port  
Grand Bahamas  
on 29 March 2010**

**Independent Investigation**

**Jacques Obadia**  
Occupational Safety  
and Health Expert

**15 June 2010**

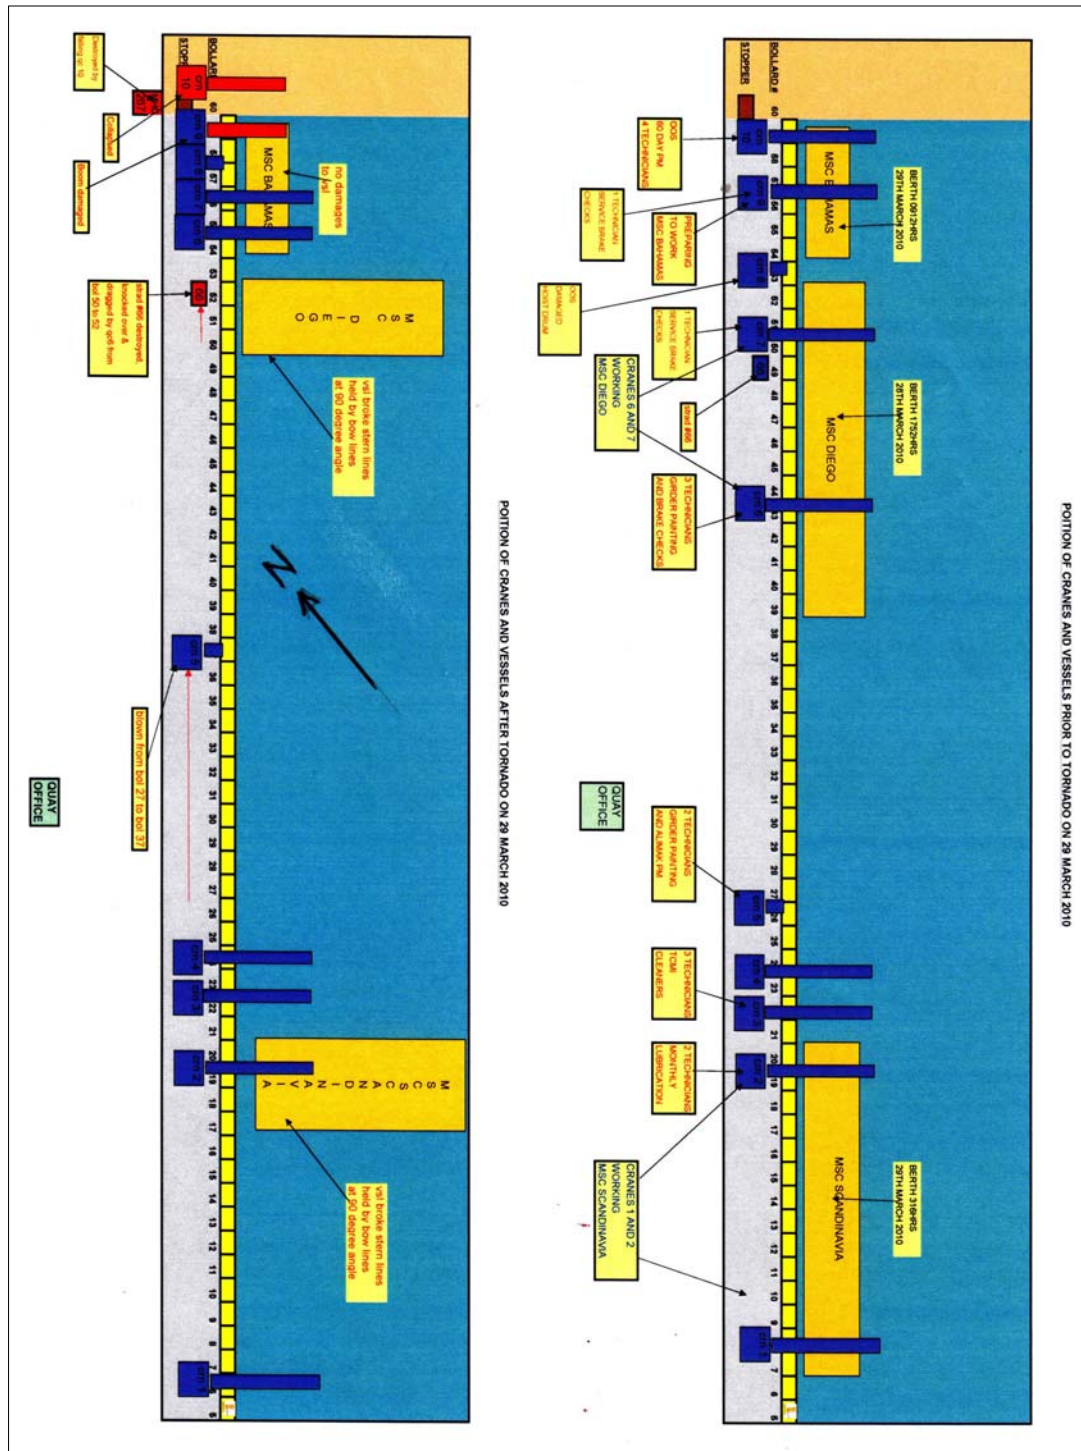
## Annex 4. Terminal situation before and after the tornado passage

10. Within those few minutes, one crane was pushed over a 100 m and four other 1000 ton cranes were sent crashing together into the last crane at the end of the gantry tracks, toppling it to the ground. This very short duration was confirmed by the Captain of the vessel MSC Diego who also estimated it at no more than 3 minutes with wind speeds at over 90 mph. The impact of the tornado was strong enough to break the stern mooring lines of two of the docked ships and push them in a near perpendicular position to the quay. Apart from broken stern mooring lines, the docked vessels did not sustain any damage.

11. The report written by the FCP Safety and Security Manager following the incident provides a concise description of the aftermath following the tornado passage over the Terminal, including rescue operations and a preliminary inventory of damages sustained by the cranes, a straddle carrier and containers. A diagram made by the FCP shows very clearly the positions of the 10 gantry cranes; the Gottwald crane and the two vessels before and after the tornado passage (see Annex 4).
