**DEPARTMENT OF ENVIRONMENTAL HEALTH SERVICES**

# SHANTY TOWN PROJECT 2013

## FOREWORD

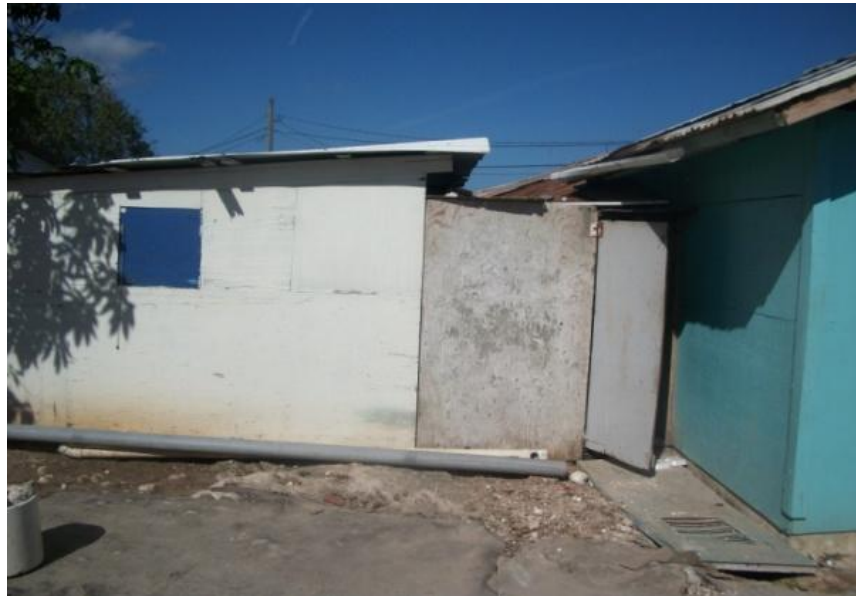
- All buildings in these “shanty towns” are made from discarded wood or metals without any regard for the Bahamas Building Code. Construction was ongoing in most of these “towns”.

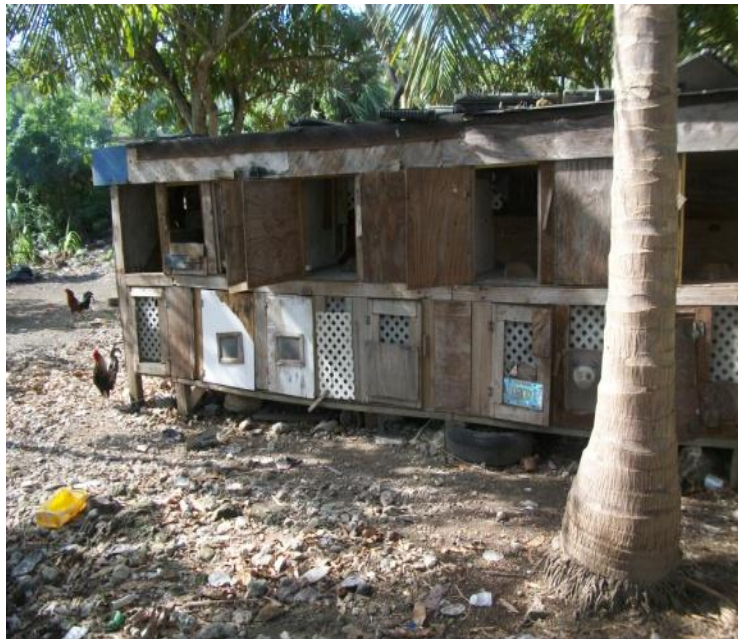
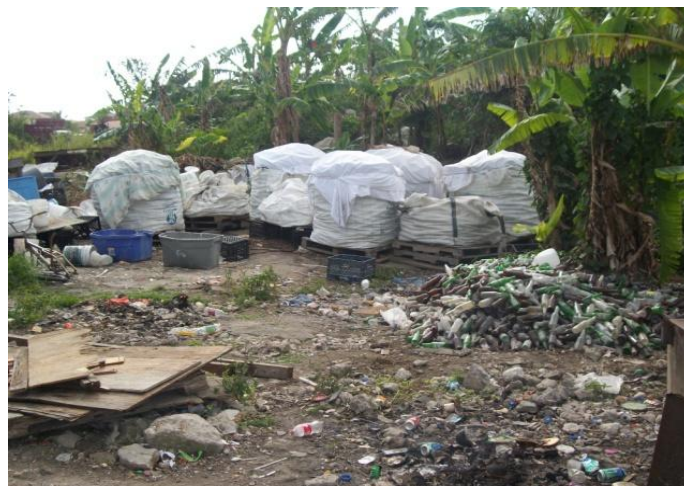
- A number of the structures are now rented by Haitians to persons claiming to have Bahamian Citizenship and illegal immigrants.
- Profitable businesses of varying nature, inclusive of liquor stores, convenience shops, numbers, animal rearing (chickens, sheep, goats, and pigs), cock fighting, recycling of bottles, and coal production, are being operated in these towns.

- The storage of bottles being housed in these “towns” gives rise to mosquito and other disease carrying vectors.
- Manufacturing of coal seems to be a big business. The Bahamian Pine is being utilized in disregard to the Forestry Act.
- Water is available in all “towns,” and in some instances being piped into houses. Of great concern is the biological quality of the water. Only three (3) of the forty six (46) samples taken meet World Health Organization (WHO) Standards. All the others failed with very high fecal coli form counts. Two of the samples had residual chlorine present.

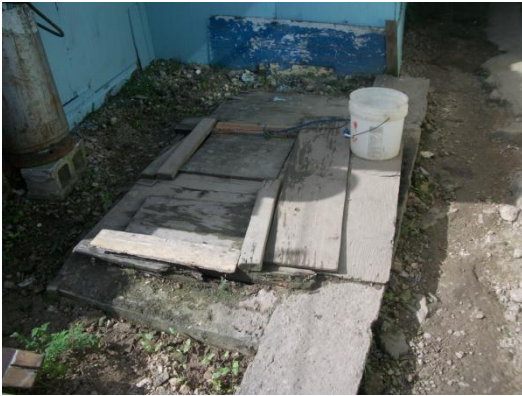
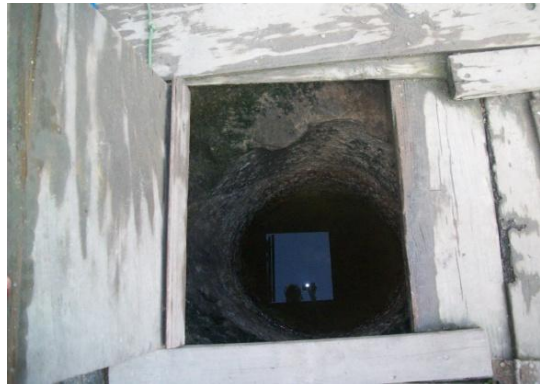
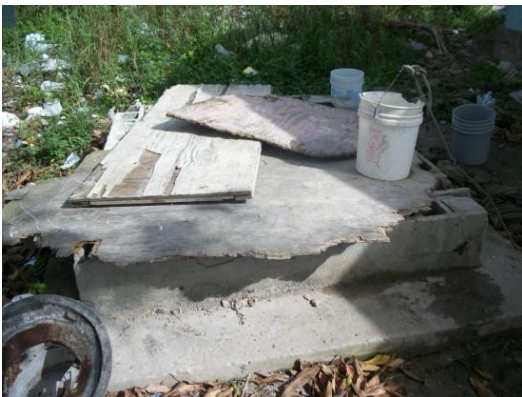
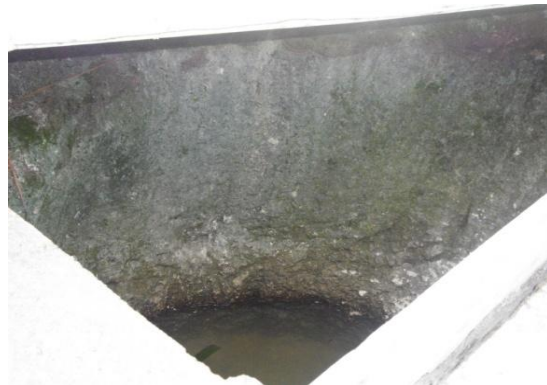
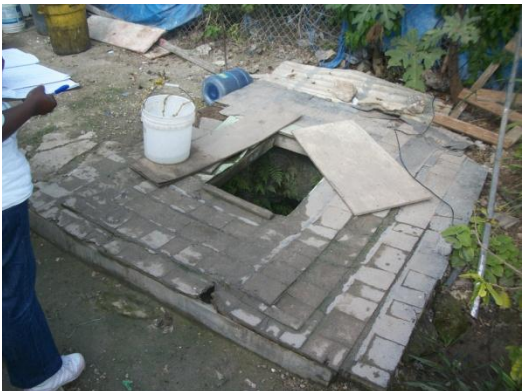
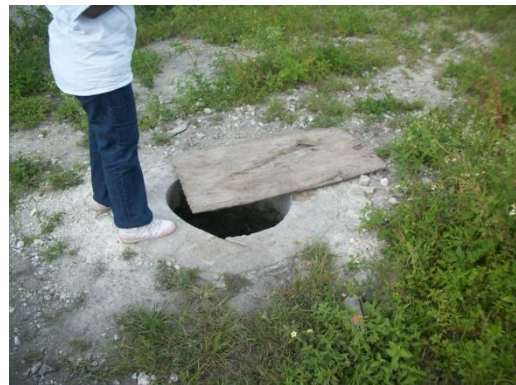
Bucket wells are most common. These open, untreated water sources are undesirable due to their susceptibility to contamination from runoff and debris.

Closed well supplies are also unsatisfactory due to their improper construction, proximity to improper sewage systems and the natural fluctuation of groundwater quality.

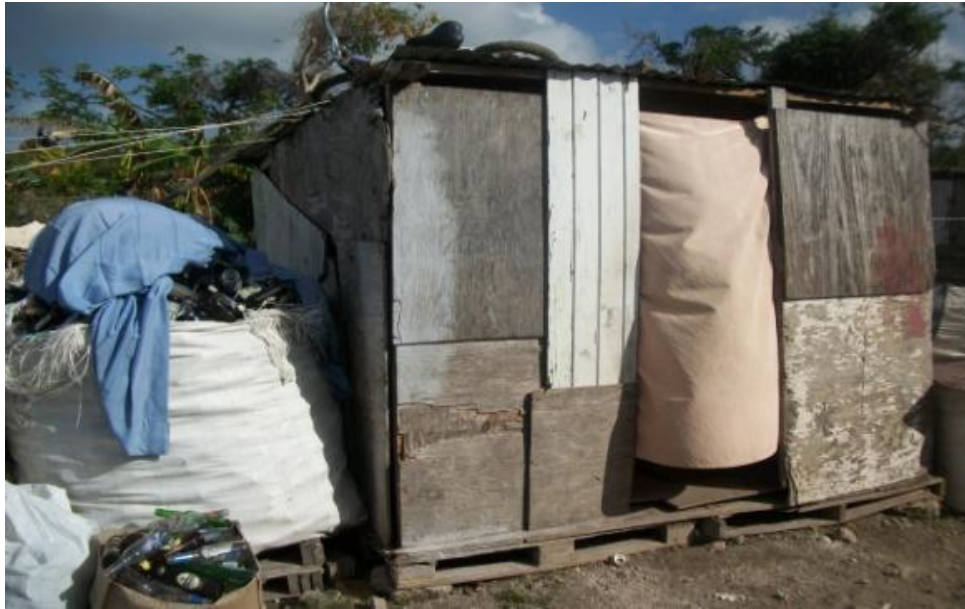
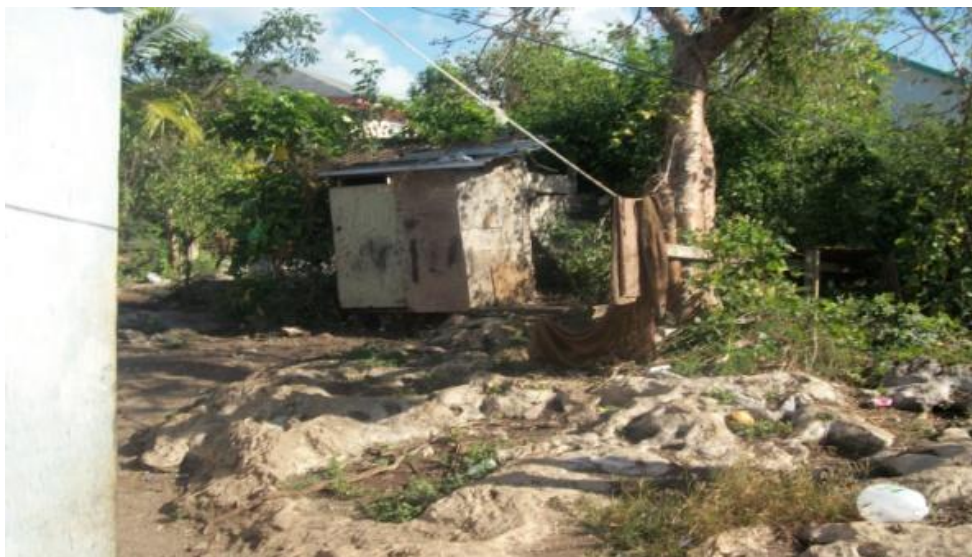
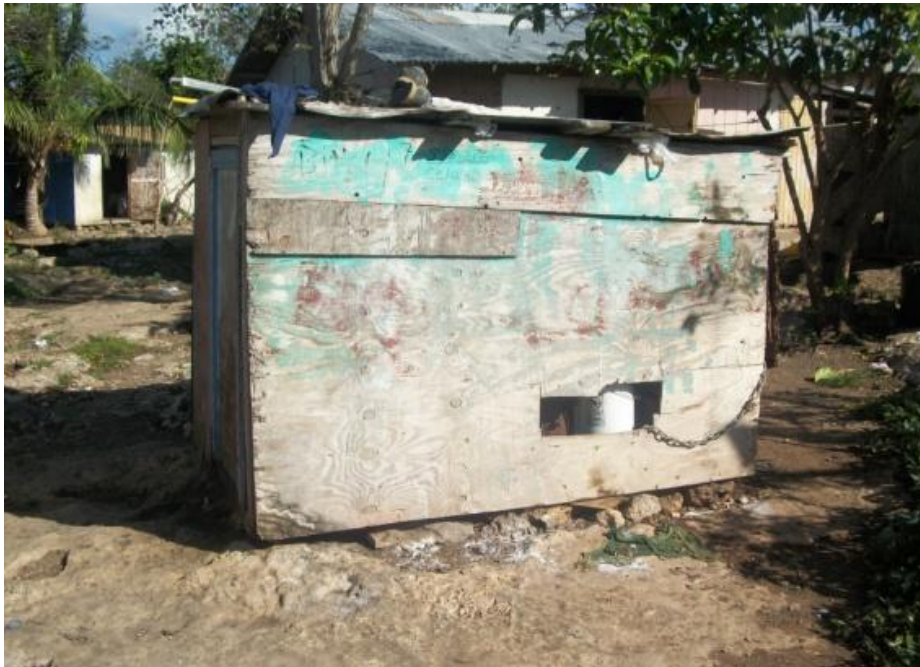
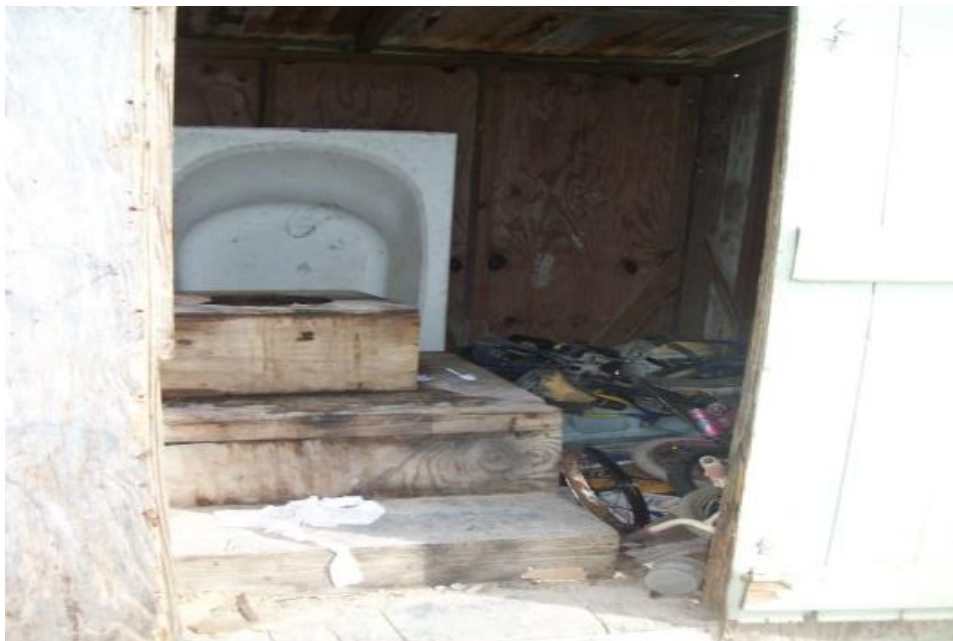
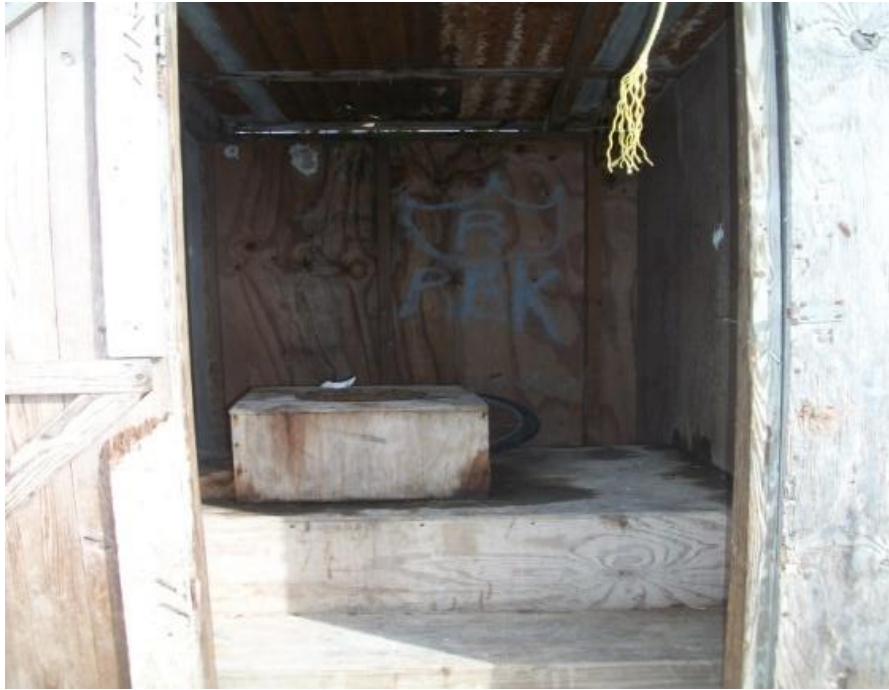
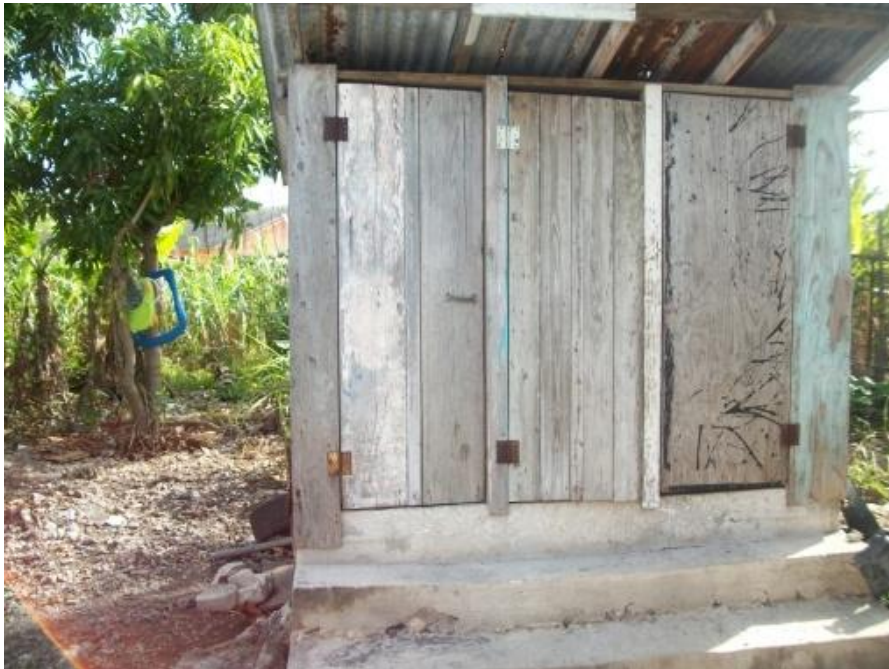
- Attempts have been made to provide some form of sewage disposal. None of the structures provided conform with the law and in most cases are in a state of disrepair.

- The number of sanitary conveniences is not in proportion to the population. Human feces was observed in common walking areas between dwellings, in nearby bushes, and around animal pens. The inadequate disposal of sewage increases the risk of transmission of fecal-borne diseases and contamination of groundwater supply.

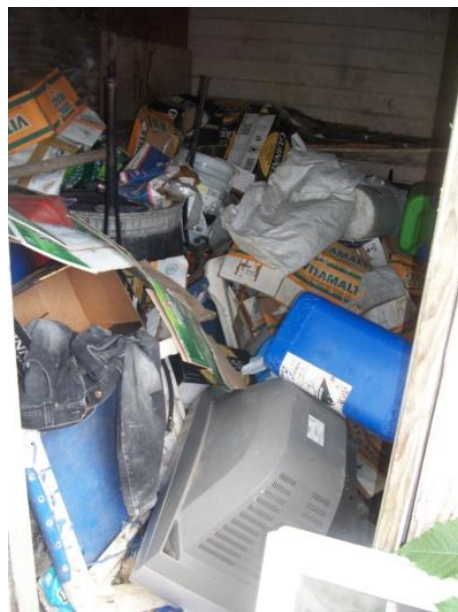
- Household refuse, mostly food byproducts, are routinely thrown outdoors, often within the pathway, around the houses, or wherever is convenient. There is strong indication of rodent infestation in and around living/sleeping quarters as evidenced by live rats, and burrows.

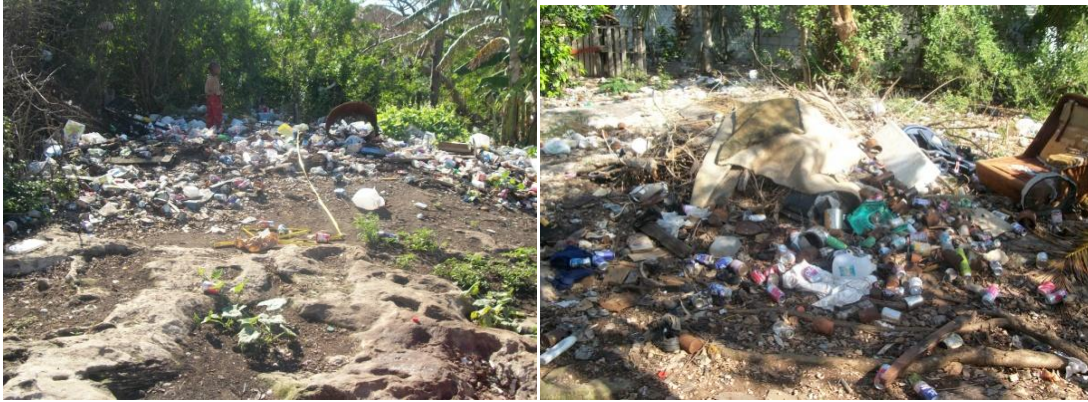
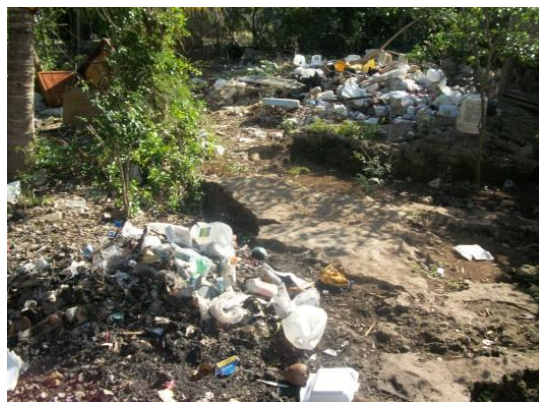
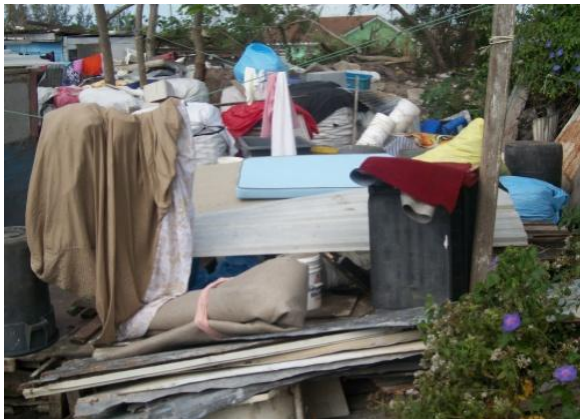
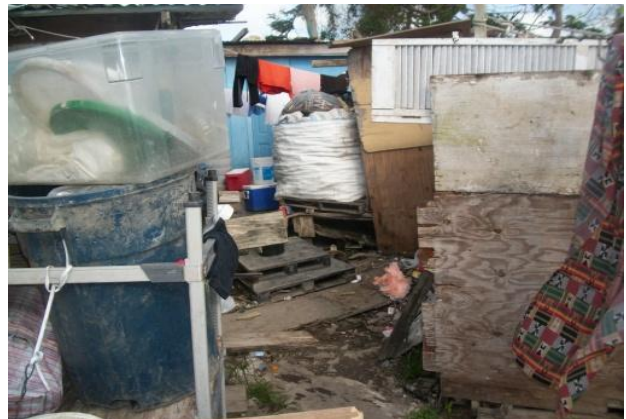
- Due to the layout of most of these “towns” the Department of Environmental Health is unable to provide individual residential collection. Residential waste placed at the front of the property in proximity to the main road is collected. This method is not very successful as most of the houses are located far away from the road and residents are reluctant to bring waste the distance required for proper disposal. This obviously results in garbage being deposited throughout these “towns,” and nearby bushes.

- The proliferation of derelict vehicles is a major concern as they serve as harborage for vectors such as mosquitoes and rodents.

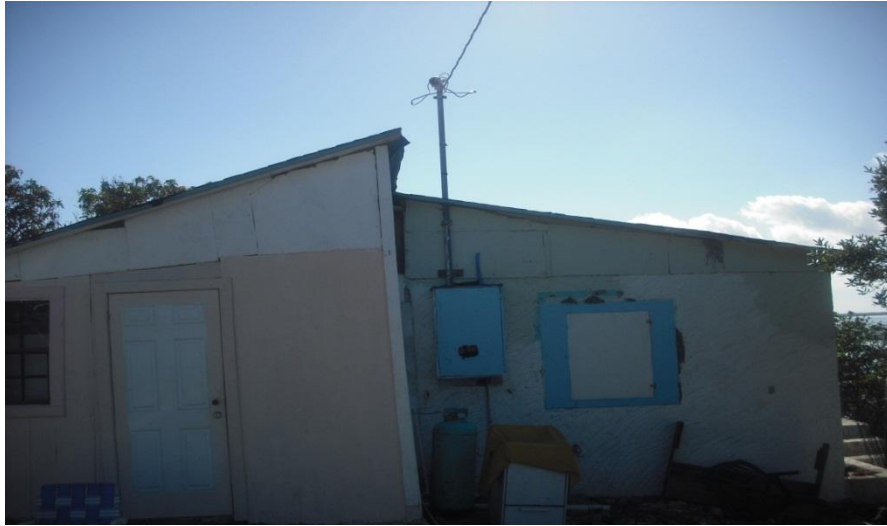
#### 1. Spanish Wells

Housing	Adults	Children	Water Supply	Sewage Disposal	Waste Management
Wooden structure	2	5	Private well	Insanitary privy closet Improper septic tank	Garbage & refuse Accumulation

Privy closet

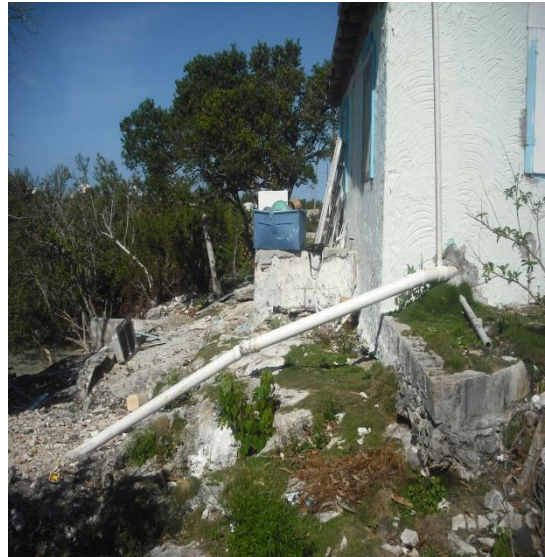
Waste pipe leading to improper septic tank

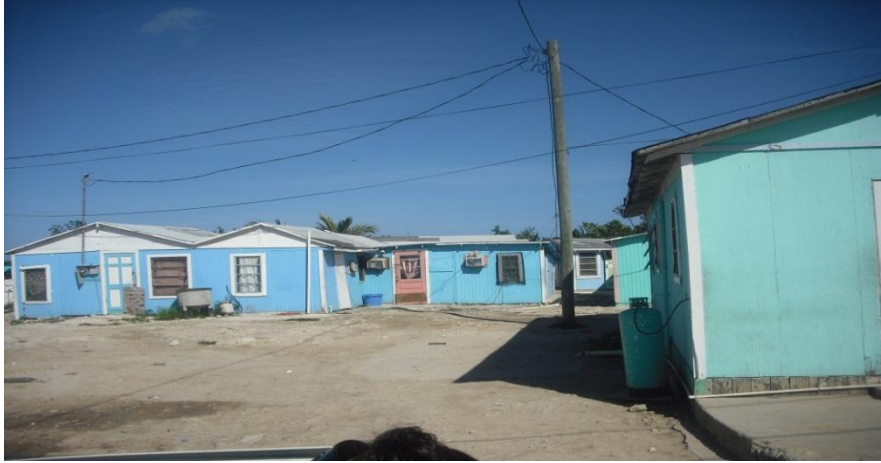
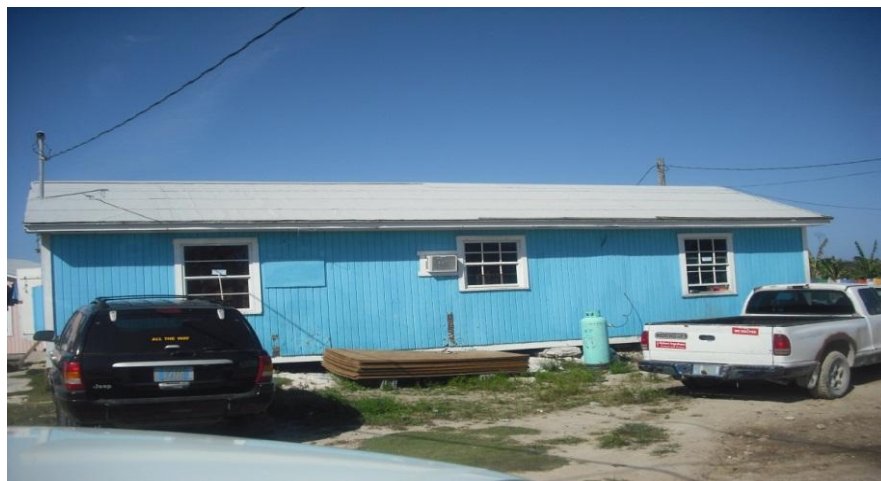
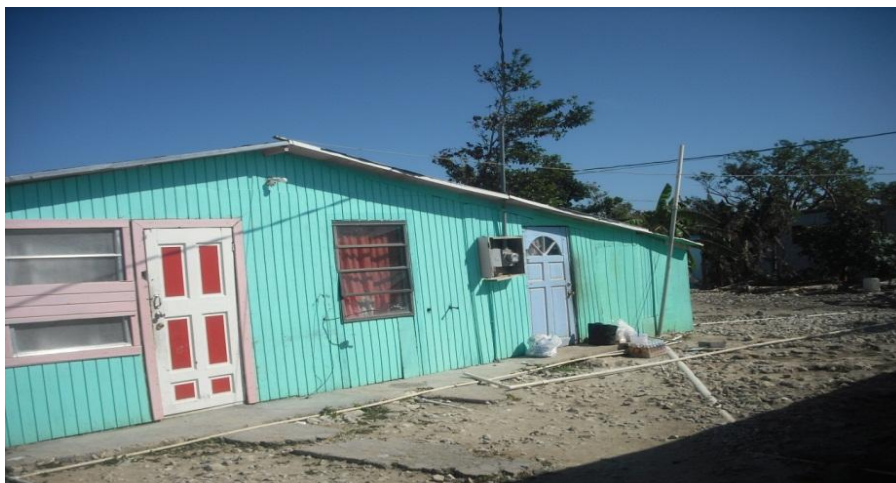
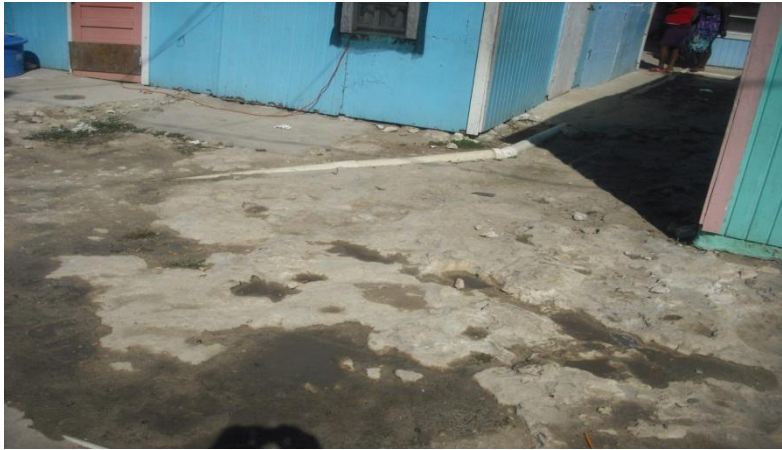
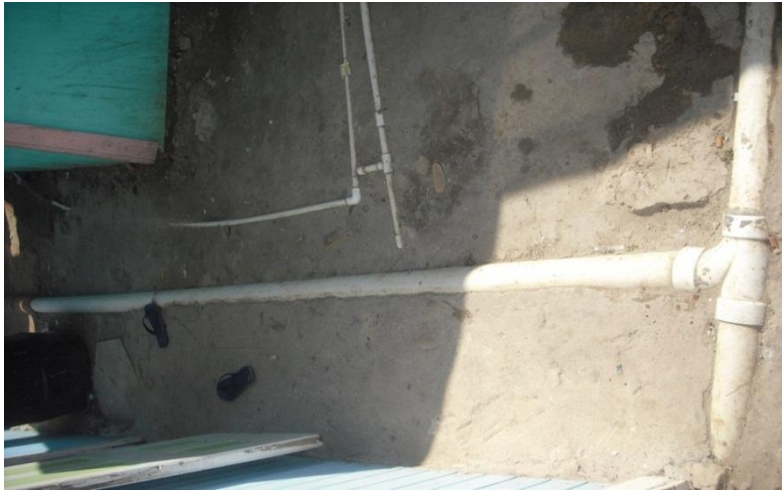
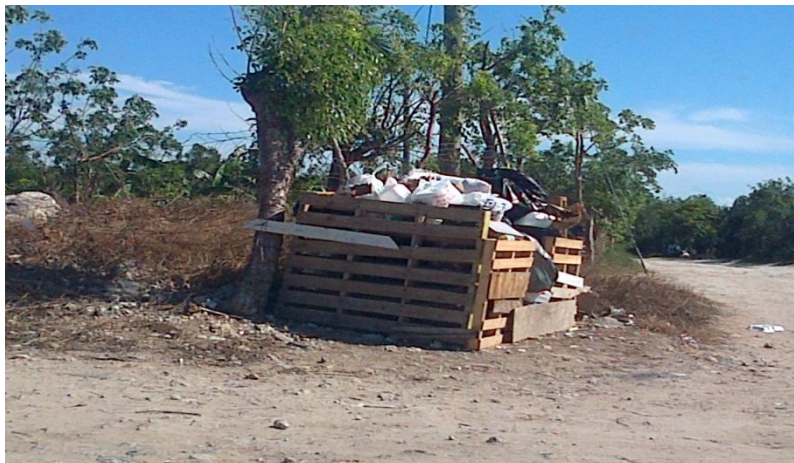
<b>Housing</b>	<b>Water Supply</b>	<b>Sewage Disposal</b>	<b>Waste Management</b>
16 Wooden structures	Private Well	Septic tank, not built to code	Insufficient garbage storage bins Refuse accumulation

**Property is occupied by twenty three (23) adults and twenty one (21) children.**

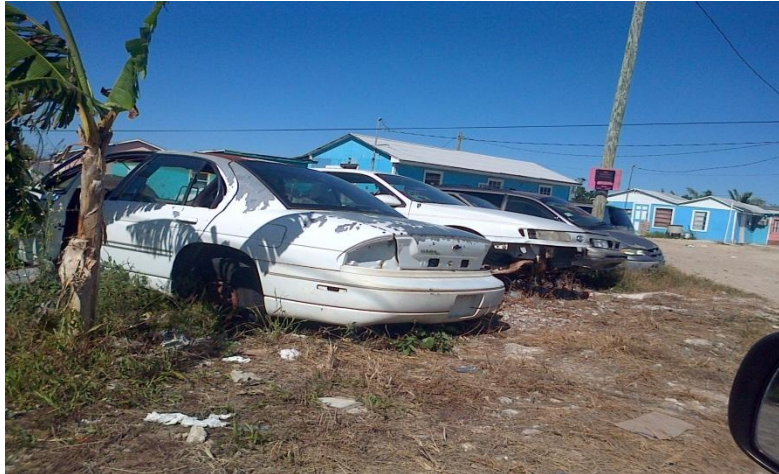
## Garbage storage

Derelict vehicles

Housing	Adults	Children	Water Supply	Sewage Disposal	Waste Management
Wooden structures	2	5	Private well	Septic tank, not built to code	No garbage storage bins

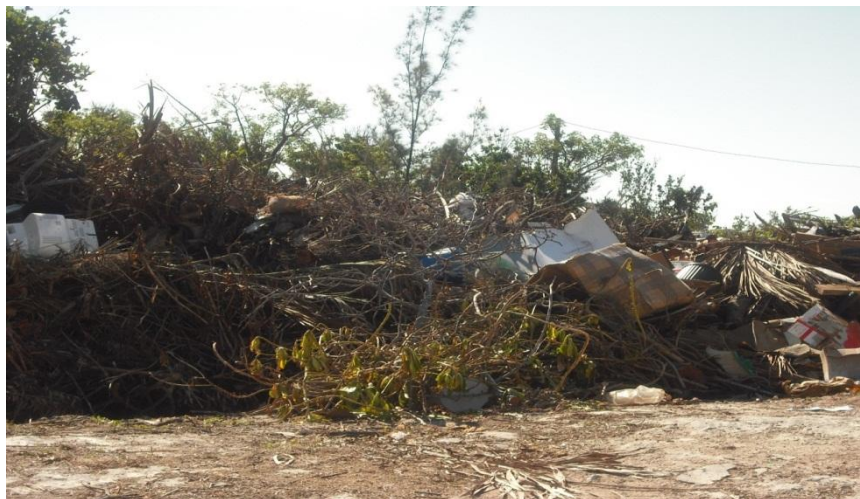
Piles of yard debris that were deposited near to the gated entrance of Gun Point

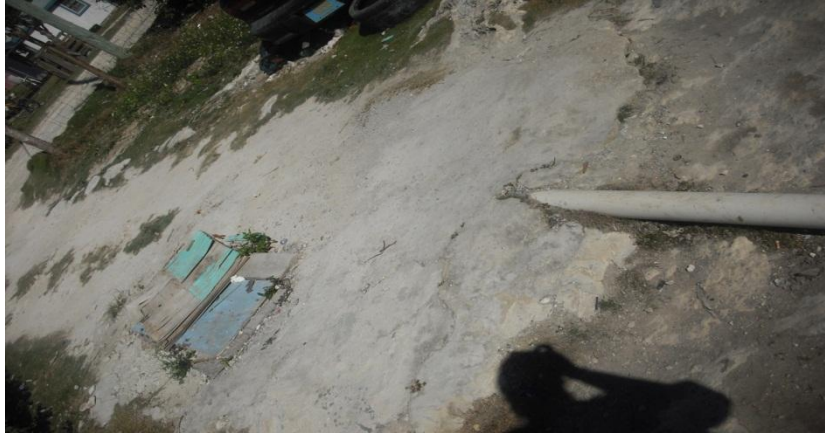
Photo showing the construction method of septic tanks

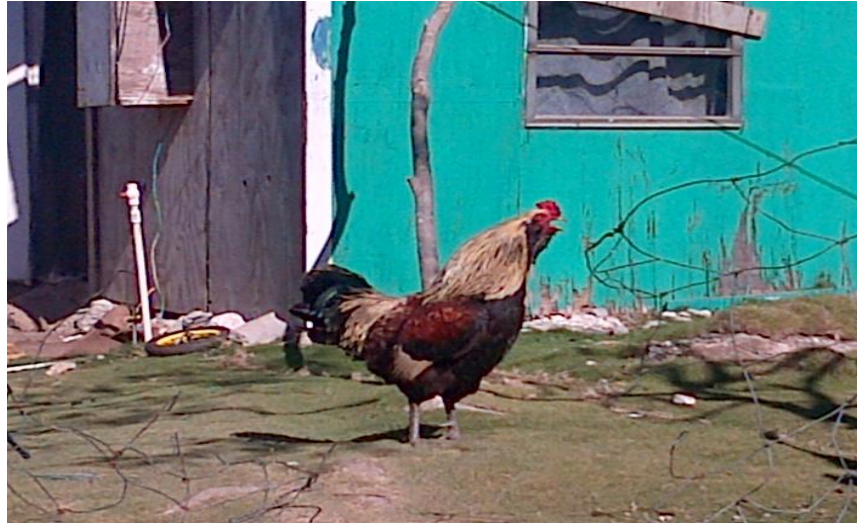
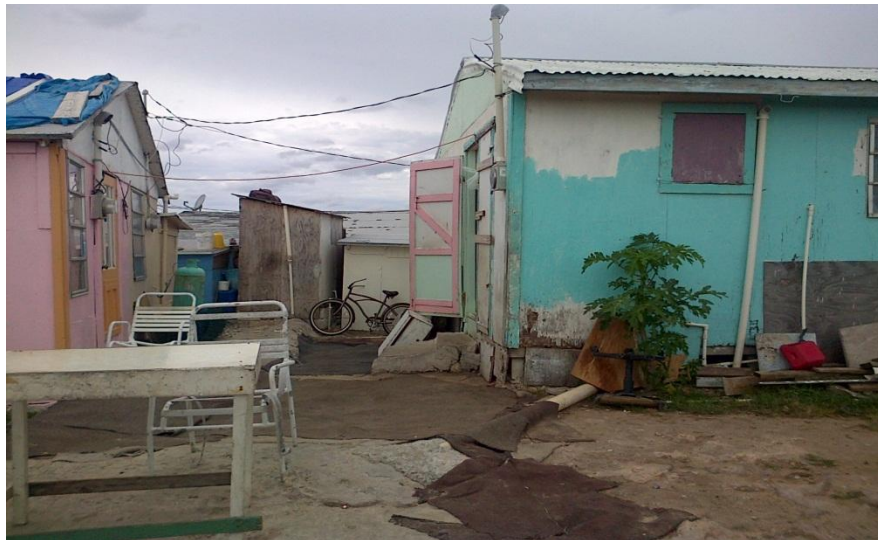
Example of water tanks in Blackwood

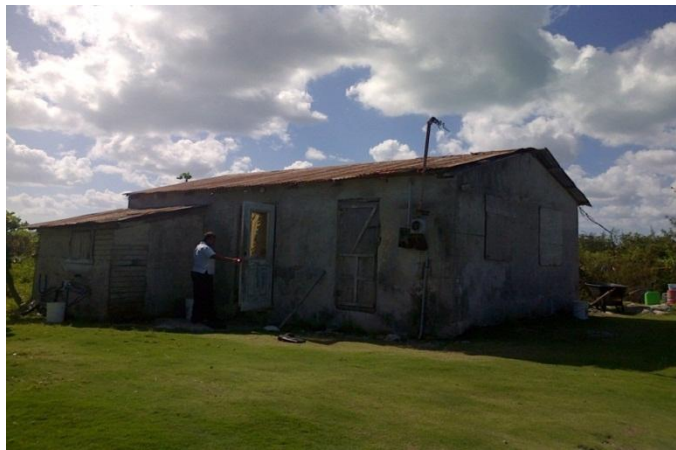
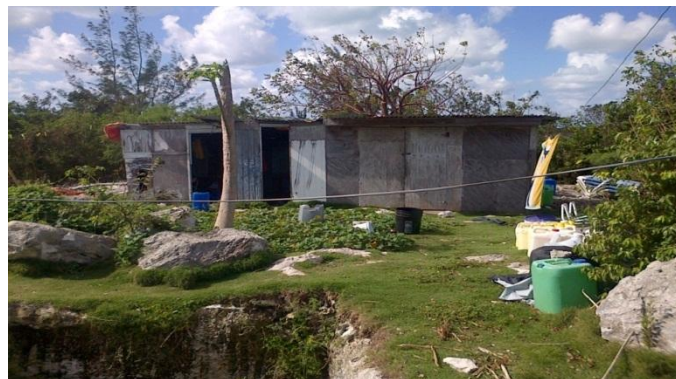
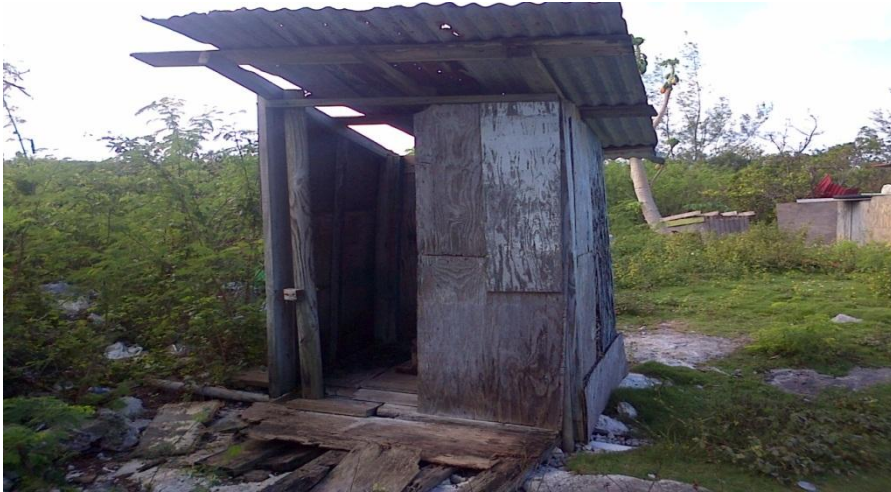
Housing	Water Supply	Sewage Disposal	Waste Management
2 structures (one stucco, one wooden)	Standpipe No running water	Insanitary privy closet	No garbage storage bins Refuse accumulation

Insanitary privy closet (outside view)

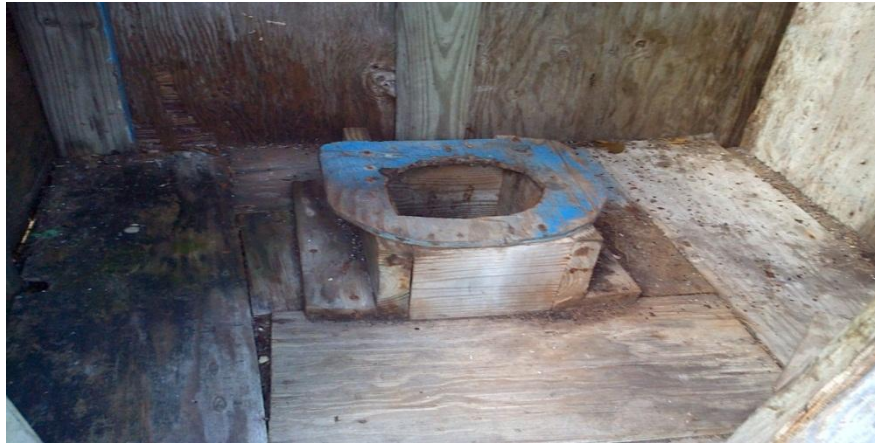
Privy closet (inside view)

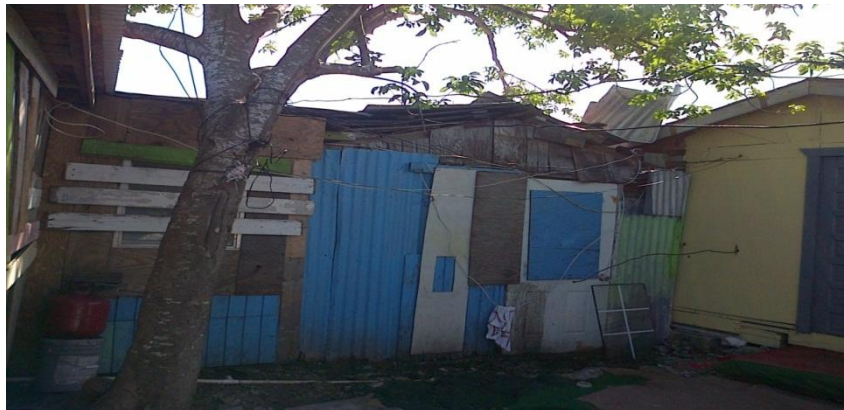
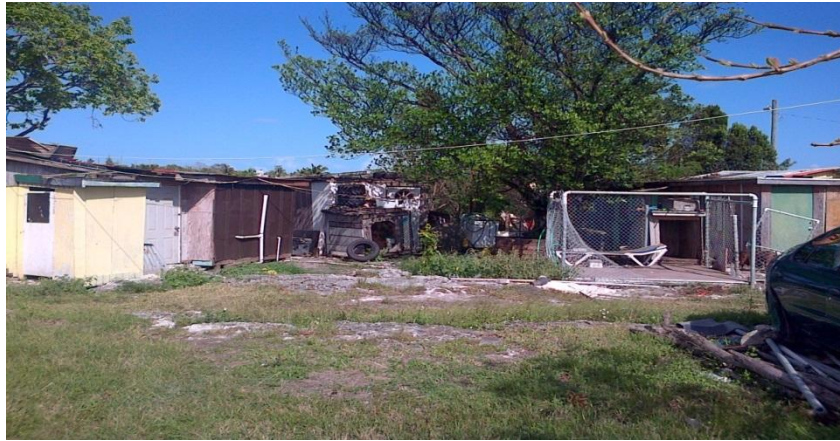
## GREEN CASTLE

This property was grossly insanitary with huge piles of refuse accumulation and septic tanks that are not built to code. Also, there was a Pit Bull dog on the compound which made it impossible to conduct a thorough inspection of the premises.

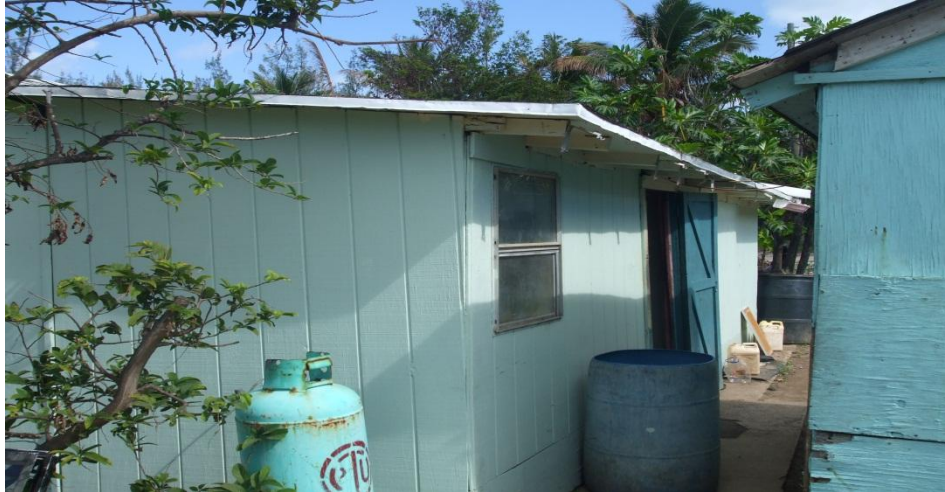
Housing	Adults	Children	Water Supply	Sewage Disposal	Waste Management
Wooden structure	3	2	Stand pipe	Septic tank not built to code	No garbage storage bins Refuse accumulation

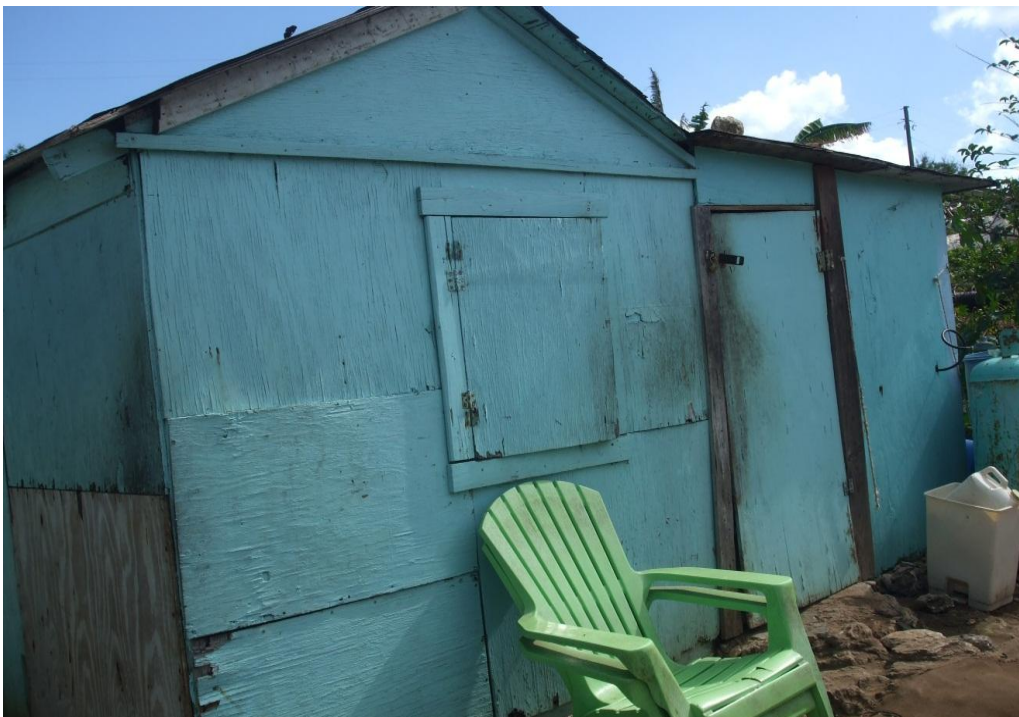
Housing	Adults	Children	Water Supply	Sewage Disposal	Waste Management
Wooden structure	2	1	Stand pipe	No sanitary facilities	No garbage storage bins Refuse accumulation

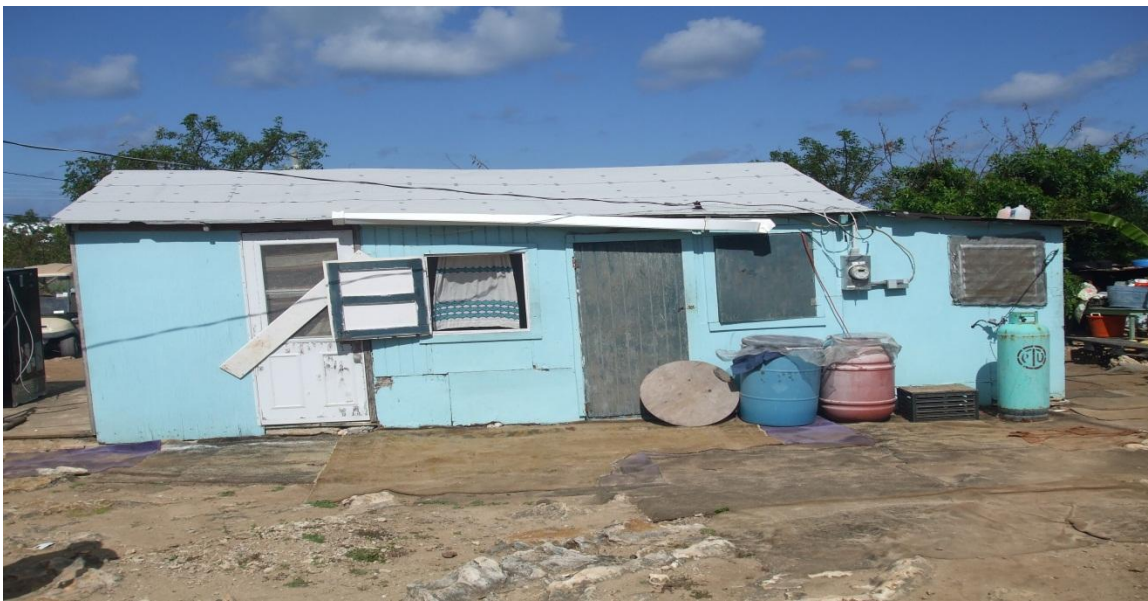
Housing	Adults	Children	Water Supply	Sewage Disposal	Waste Management
Wooden structure	3	0	City connection	Septic tank not built to code	No garbage storage bins Refuse accumulation

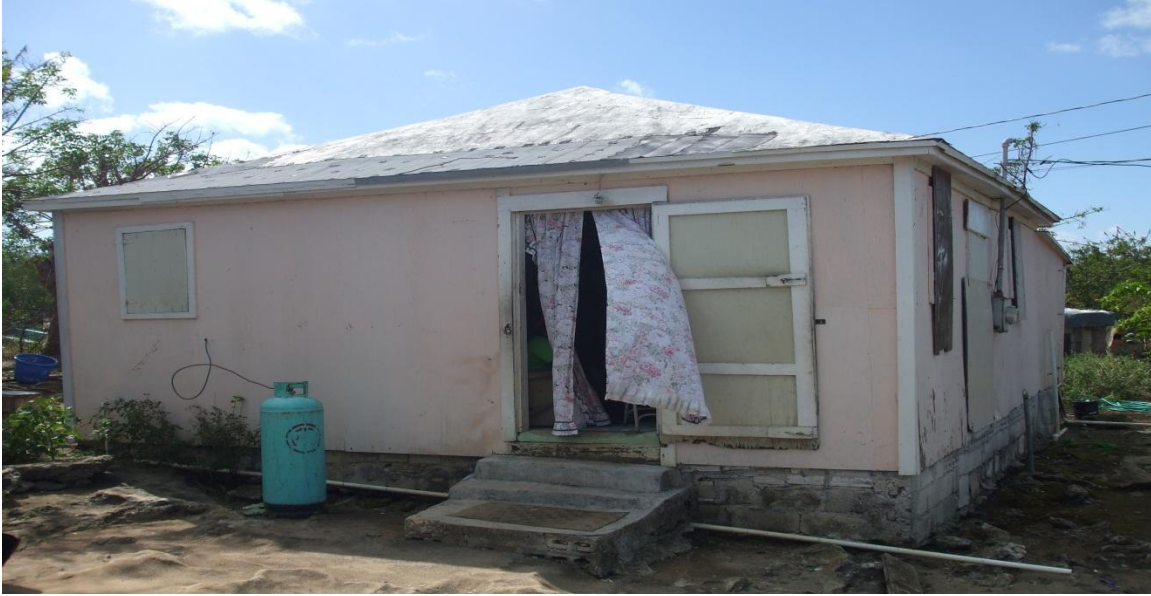
Housing	Adults	Children	Water Supply	Sewage Disposal	Waste Management
Wooden structure	2	2	City connection	Septic tank not built to code	No garbage storage bins Refuse accumulation

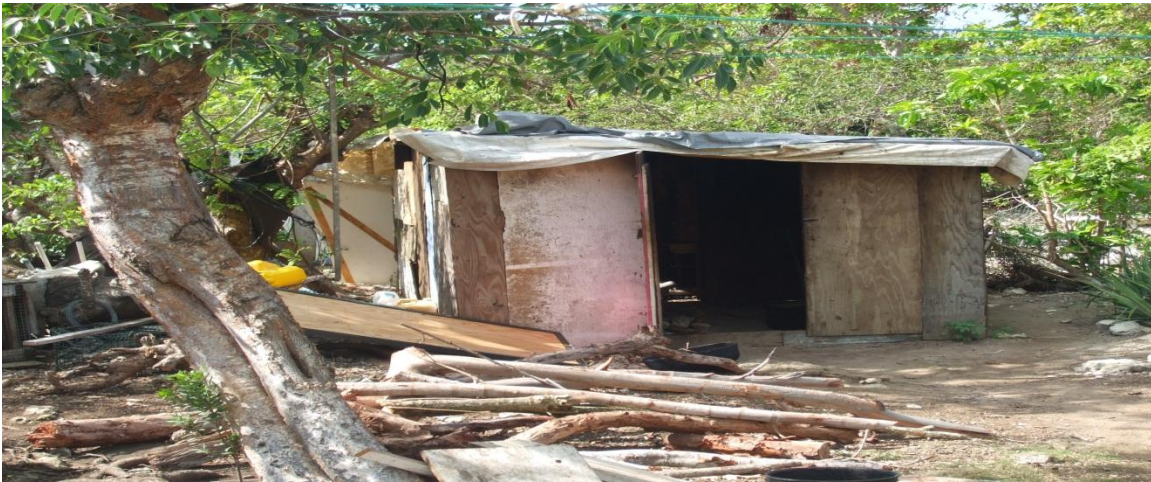
Outside kitchen

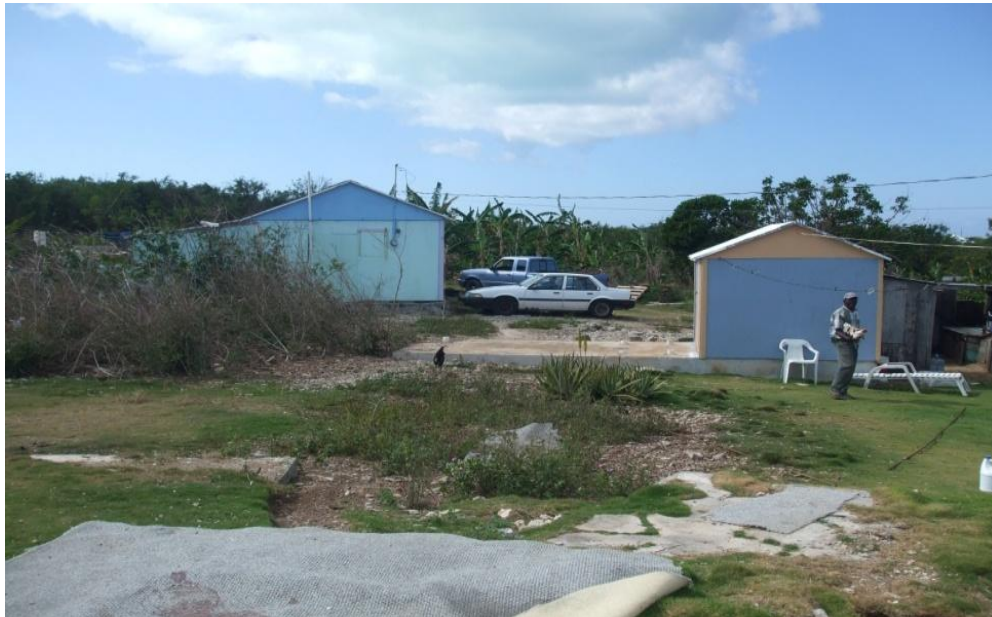
Housing	Adults	Children	Water Supply	Sewage Disposal	Waste Management
Wooden structure	2	0	City connection	Septic tank, Open drainage	Refuse accumulation/burning

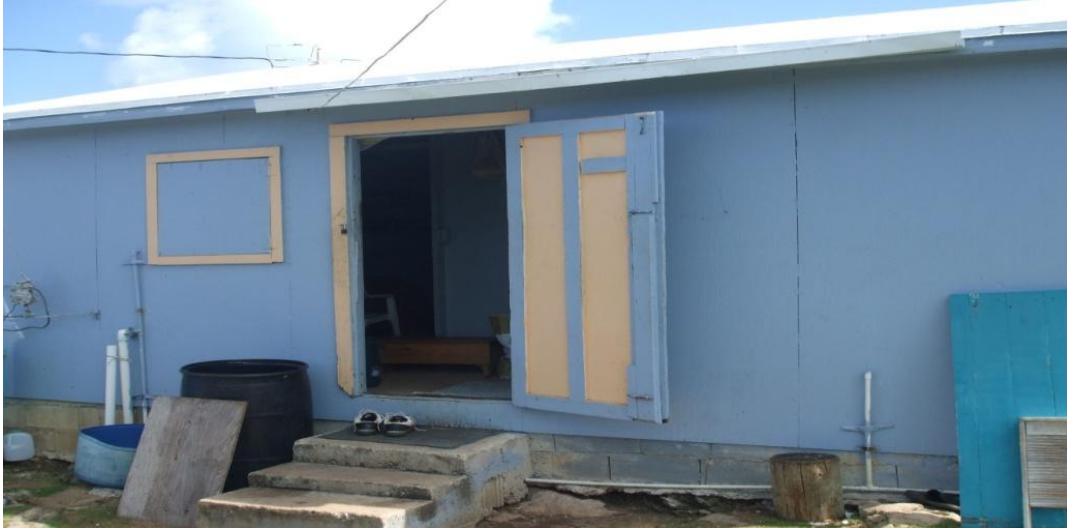
Housing	Adults	Children	Water Supply	Sewage Disposal	Waste Management
Concrete/Wooden structure	3	2	City connection	Septic tank not built to code	No garbage storage bins Refuse accumulation

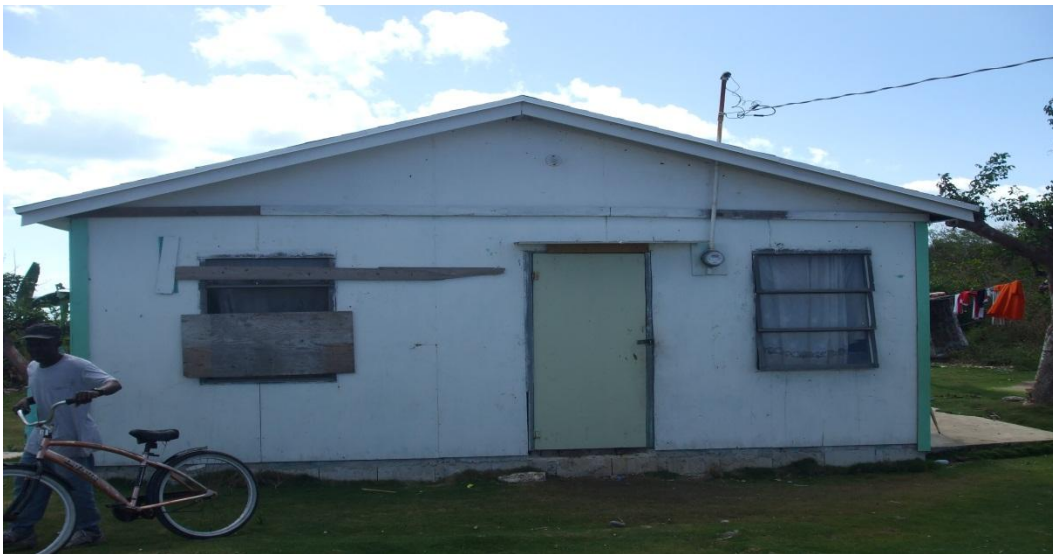
Housing	Adults	Children	Water Supply	Sewage Disposal	Waste Management
Wooden structure	1	0	City connection	Septic tank	Storage bins

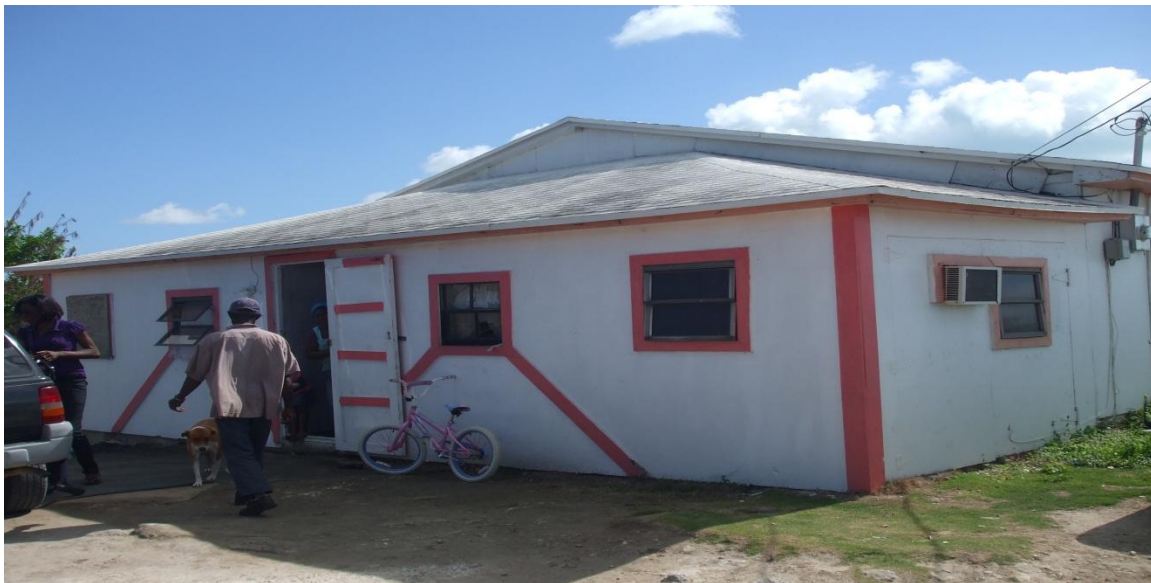
Housing	Adults	Children	Water Supply	Sewage Disposal	Waste Management
Wooden structure/ 2 units	3	0	City connection	Shared Septic tank	Storage bins

Housing	Adults	Children	Water Supply	Sewage Disposal	Waste Management
Shared unit	2	4	City connection	Shared septic tank	Storage bins

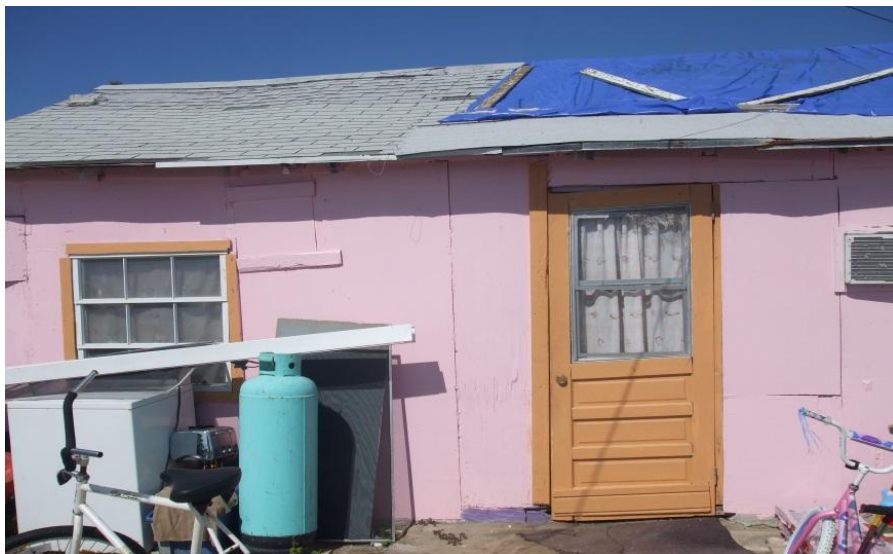
<b>Housing</b>	<b>Adults</b>	<b>Children</b>	<b>Water Supply</b>	<b>Sewage Disposal</b>	<b>Waste Management</b>
Shared unit	2	3	Shared Well	Shared septic tank	Storage bins Refuse accum.
