**DEPARTMENT OF ENVIRONMENTAL HEALTH SERVICES**

# SHANTY TOWN PROJECT 2013

## FOREWORD

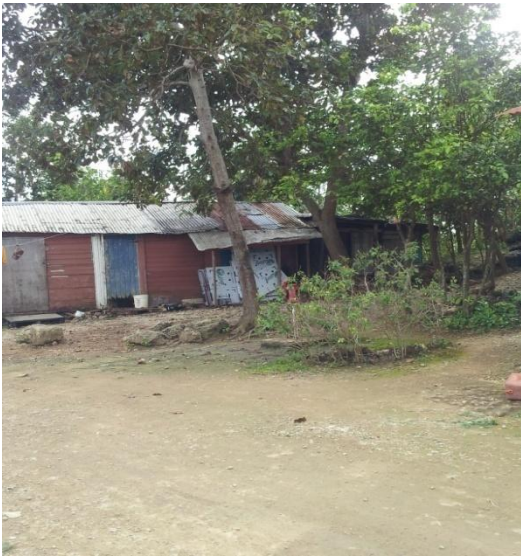
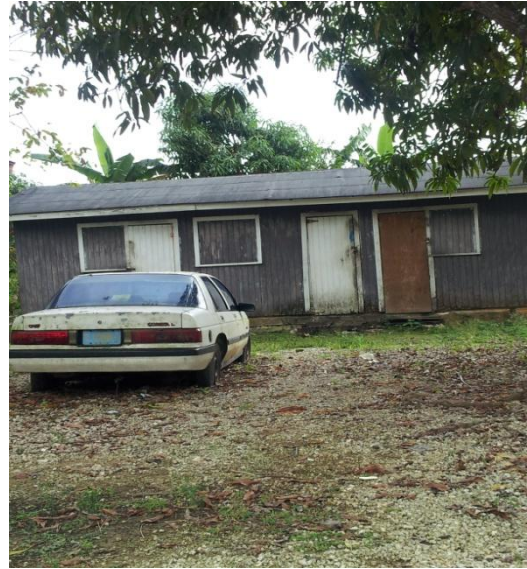
The Shanty Town in Andros is located near the Heastie farm property, San Andros, Bahamas. Thirty (31) structures were in the village with some of the structures consisting of up to six (6) sections in the dwelling structure.

Three (3) residences have proper bathroom facilities, two (2) outside toilets are shared in the towns. Most residents use nearby bushes to dispose of waste.

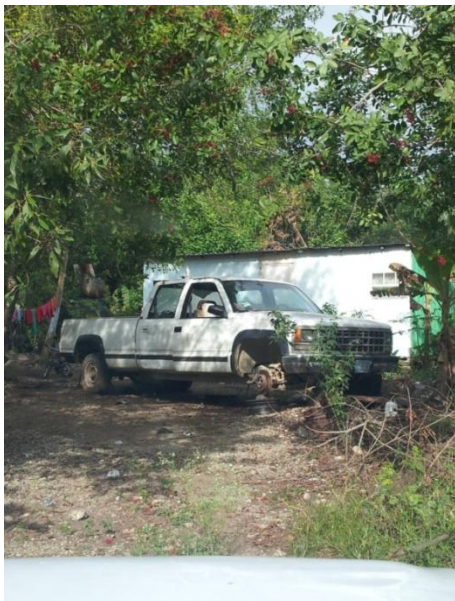
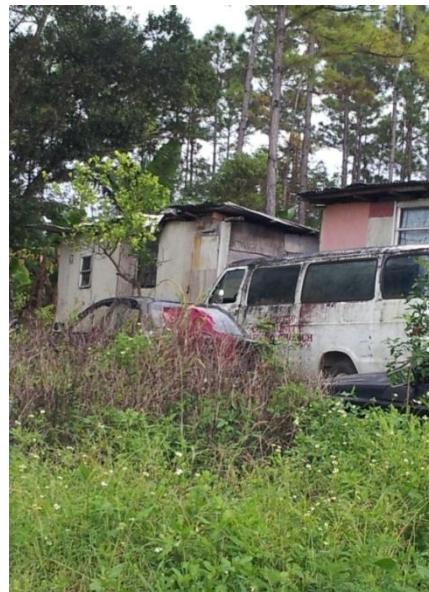
Many of the premises are kept in a clean and sanitary condition, whereas others have household garbage accumulation and derelict vehicles at the rear of the property. Garbage and debris are disposed of in nearby bushes.

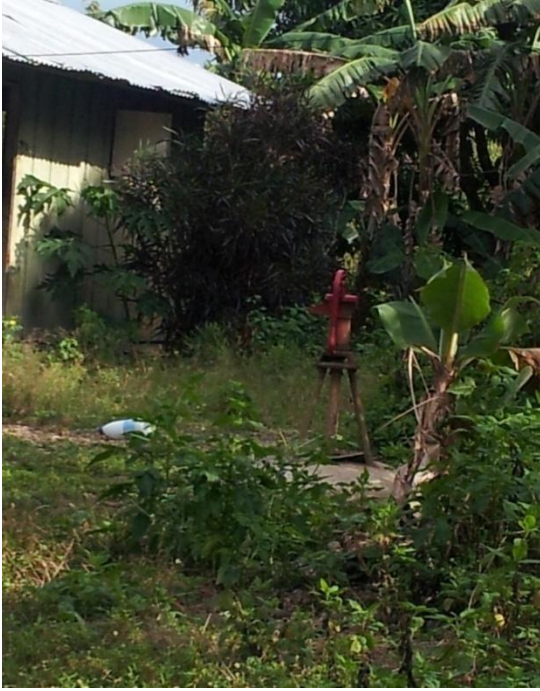
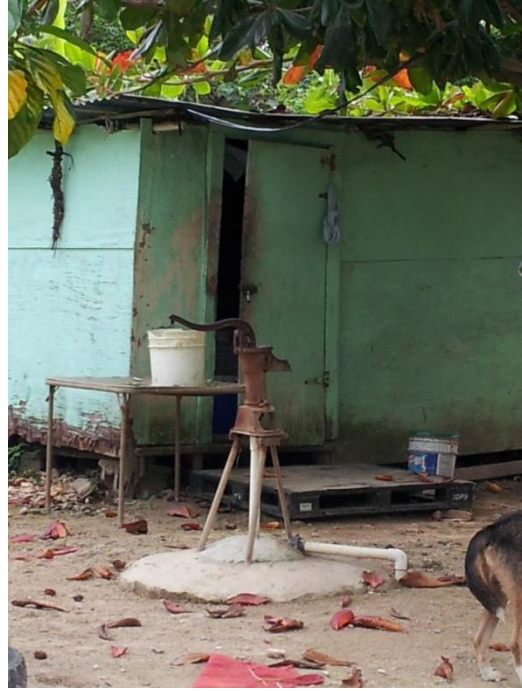
Hand pumps and open wells can be found throughout the town as there is no piped water with the exception of three (3) that have running water by the use of electric pump.

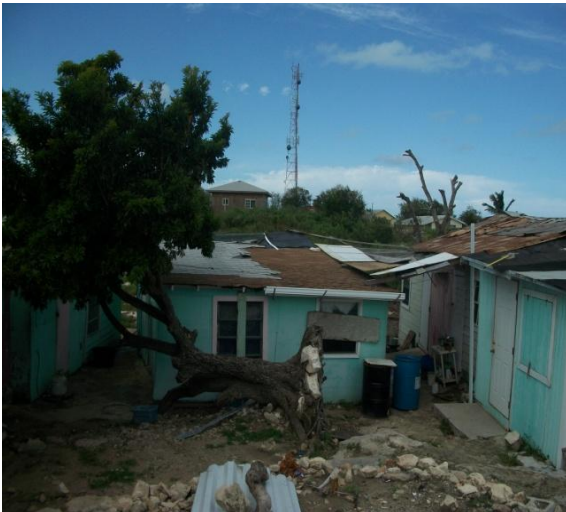
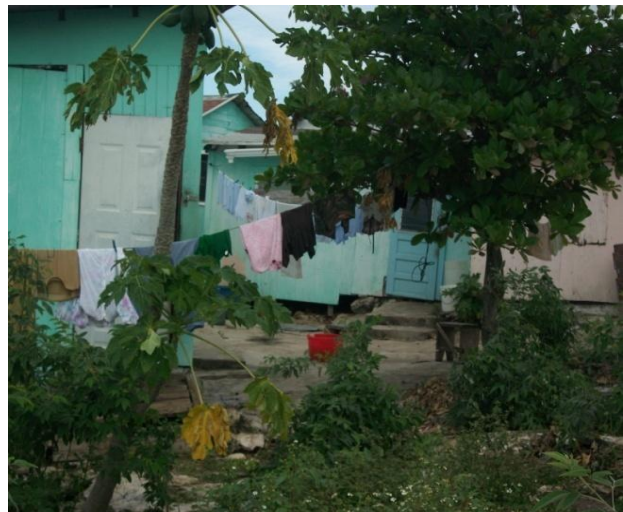
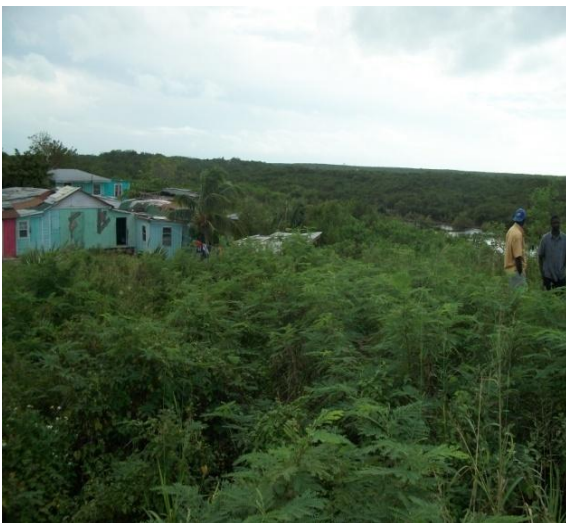
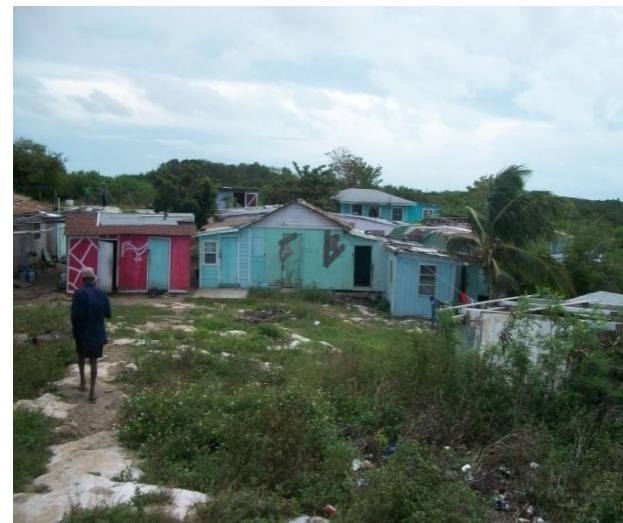
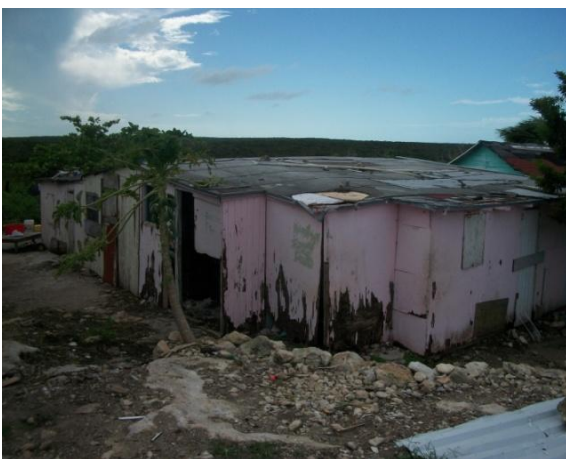
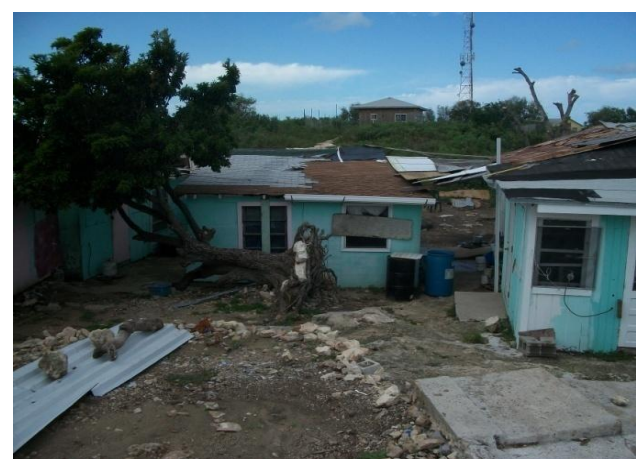
Within the Cooper's Yard town there are seven (7) structures.

Home one (1) has six (6) doors/units - occupied

- Home two (2) has three (3) doors/units – abandoned/dilapidated (pink)
- Home three (3) has two (2) doors/units- unoccupied.
- Home four (4) has five (5) doors/units -occupied.
- Home five (5) has two (2) doors/units – unoccupied (lime green).

Home six (6) – occupied

Home seven (7) - occupied

These homes have:

Two septic tanks – 2 buildings connected (green & white)
